ARS 42-45 April 1961

Evaluation of

# CONSTRUCTION, MATERIALS, AND LIVABILITY

of Five Expansible Farmhouses

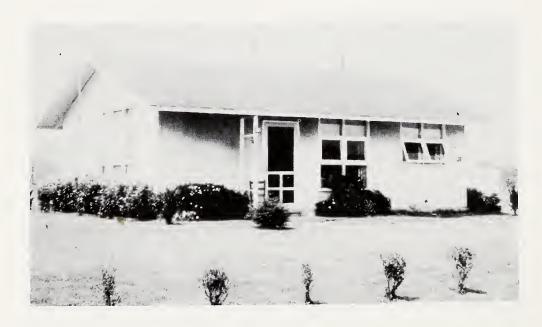
FIGURE 2. -- House A.

Technical evaluation. -- Asbestos-cement board covering the exterior walls shows no signs of deterioration, cracks, or discoloration, and presents an attractive surface which is relatively maintenance free.

A crack appeared near the center of the ceiling continuing practically from wall to wall beneath the ridge. Inspection revealed a measured deflection of 1/4" near the crack; this is slightly more than normal camber but is not alarming. Because a vapor barrier was applied over the insulation in the attic as an experimental feature, the plasterboard softened from high-moisture content. The size of the crack, caused by structural movement, was thus increased when the plasterboard dried out.

The large window on the south side admits excessive light and sun which fades the upholstery and rug and causes discomfort in warm weather.<sup>3</sup>

<sup>3</sup> This condition could be improved with some sort of outdoor shading or a different window drapery treatment,

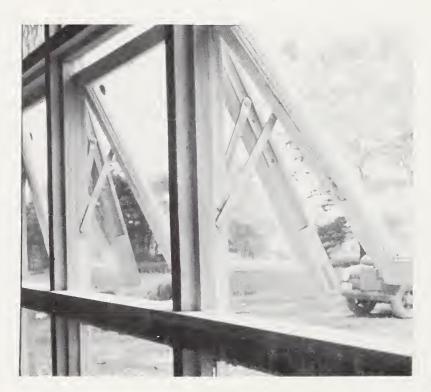
FIGURE 4.--Frameless window jambs, House A.

The studs serve as jambs for the frameless windows and sash is hinged at top to provide ventilation (fig. 4). This house has two large window areas: one 7'-6" wide by 6'-6" high in the south wall of the living-sleeping room; and one 5'-0" wide by 6'-6" high in the dining area--an eastern exposure. Both windows have 1'-6" sill heights. Other windows are of conventional size.

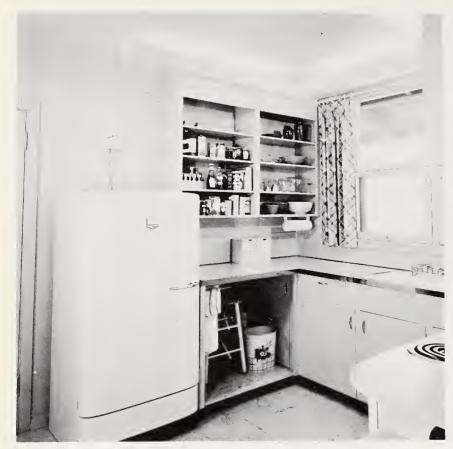
FIGURE 5.--Doorless wall cabinets, Houses A, B, and C.

possible economies in original construction, doors were not installed in wall cabinets, though they were included in the design (fig. 5).

A well-designed kitchen can be achieved in a small low-cost house. Occupants were generally pleased with their kitchens. Wall cabinets, base cabinets, and counterspace were found to approximate, and in several instances to exceed, minimum dimensions recommended by housing research workers. There was one exception: In House C there are only 6 linear feet of wall cabinets -- 8 linear feet are desirable. However, wall space is available over the range and a base cabinet for an additional 6 feet of cabinets. The cost-cutting device of omitting cabinet doors met with disfavor. All of the five homemakers wanted doors on the wall cabinets to keep shelves cleaner and the kitchen neater.

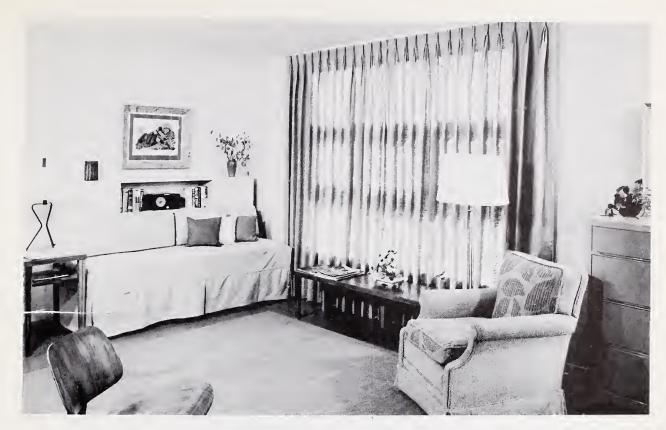
FIGURE 7.-- A possilbe solution for furnishing living and sleeping area, House A.

She was not satisfied with the combination living and sleeping room. This reaction was due in part to the appearance of the double bed which was not concealed in any way from the living area. A different sleeping arrangement (such as shown in fig. 7) or some sort of screening device would alleviate this situation. Satisfactory arrangement of conventional furniture for both living room and bedroom is difficult to achieve in a room of this size. The occupants would prefer a separate bedroom but agree that livability of the combination room would be improved if it were larger.

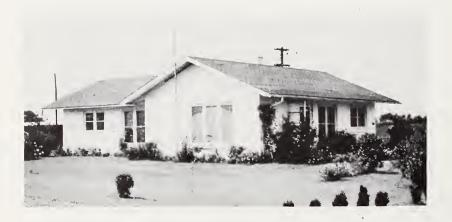
FIGURE 8.--House B.

Technical evaluation. -- Condensation on the west wall of the bedroom addition of House B has been a continual source of trouble in getting paint to adhere to the interior wall. This situation has not occurred in the basic unit of the house in spite of higher humidities which undoubtedly exist in the bathroom located in the northwest corner. Apparently the expanded mica insulation in the walls of the basic unit reduces the heat transfer sufficiently to relieve the condensation problem.

A crack, similar to that in House A (see page 5), appeared near the center of the ceiling in the basic unit. Length of crack, measured deflection, and probable cause are as described for House A.

- (a) Condensation on bedroom walls and floors due to high humidity is quite a problem in summer.
- (b) Gutters and downspouts to keep rain away from house are desirable for bedroom wing.<sup>6</sup>
- (c) The concrete floor, although covered with resilient tile, contributes to a feeling of tiredness after short periods of standing.
- (d) Quarter-round and mastic at base molding would help prevent cold air and insects from entering the house.<sup>6</sup>

- (e) The proximity of the heating plant to the bedrooms causes the occupants loss of sleep because of vibration and noise.
- (f) Location of warm air vents, high on walls, keeps floors cold in winter.

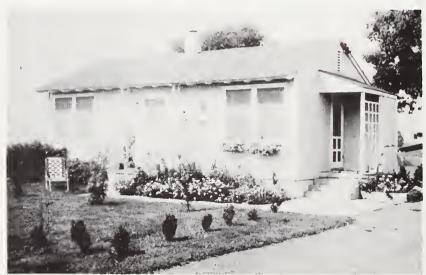
FIGURE 9. -- House C.

Technical evaluation. -- As with Houses A and B, a crack appeared near the center of the ceiling in the basic unit, continuing practically from wall to wall beneath the ridge. Since the experiment of applying a vapor barrier over the ceiling insulation was tried in all three houses, the cause of the crack in House C is also attributed to structural movement, magnified when the plaster, softened from high-moisture content, eventually dried out.

The evaluation of the heating system in House C parallels that of House B (see page 11). When the central heating plant was installed in House C, it was necessary to notch the floor joists beneath the heater to permit installation of the return air duct. After 3 years there is no evidence of damage to the floor. It may be concluded, therefore, that the joists were not unduly weakened by the cutting.

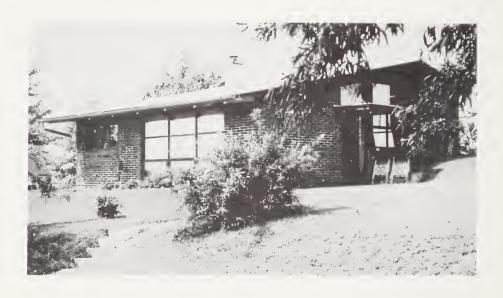
FIGURE 10, -- House D.

Technical evaluation.--The 6" SCR brick walls, while of pleasing exterior appearance, are damp and cold on the exposed interior surfaces during winter periods when sunshine is not adequate to heat walls. Eventually these walls will be furred and an interior finish applied as originally recommended by the brick manufacturer.

Roofing nails loosened and were redriven once. Further "popping" has not occurred.

The window over the back door was covered with plywood when it was found that the clear sheet glass admitted too much heat and glare from the late afternoon summer sun.

- (a) A conventional type of wall finish in lieu of the bare walls would be less cold and damp in the winter and would permit placing furniture closer to the walls."
- (b) Redwood walls in the bathroom show water stains that are difficult to remove.
- (c) A resilient tile floor covering on the upper level would be less objectionable than the present bare slab.
- (d) Windows opening at floor level are disliked because furniture cannot be placed in front of them, adequate ventilation is difficult to achieve, and small children like to swing on the open sash when they are playing out-of-doors.
- (e) The large window on the south side admits excessive light and sun.

<sup>11</sup>If given money to spend on the house, the family would fur these walls before making other improvements.

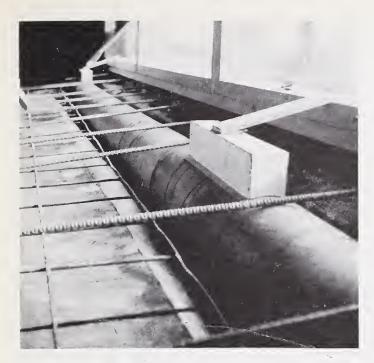
FIGURE 11.--Heating duct, House D.

The house is heated by a forced warm air system with perimeter ducts of heavy paper (fig. 11) formed within the concrete floor slab.

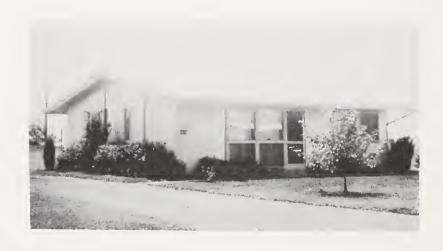
FIGURE 12, -- House E.

Aluminum sliding sash operate easily in all rooms. The screen fasteners used proved too fragile; some have been damaged and loosened, so screens do not fit properly. This allows flies and other insects to enter the house.

<sup>&</sup>lt;sup>14</sup> This homemaker's solution for the living room would be to have the lower panes of the 8'0' wide window removed and the space filled in, possibly with built-in bookcases; then the upper fixed panes would be replaced with operating sash to provide ventilation.

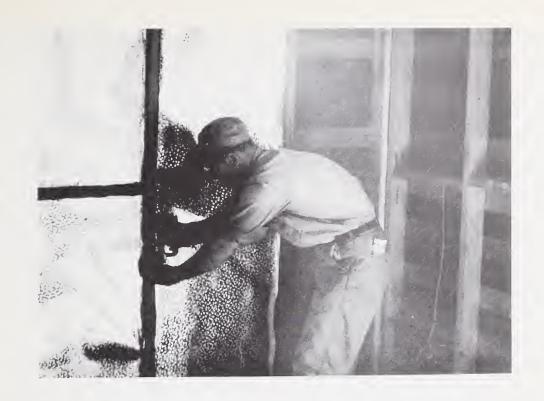
FIGURE 13.--Foil aluminum insulation, House E.

Description.--House E, commonly referred to as the alumnium house (fig. 12), incorporated certain materials furnished by industry. The exterior wall surfaces are corrugated aluminum; between the study is foil aluminum insulation (fig. 13) and on the interior face of study, a combination aluminum insulation and vapor barrier is used. The corrugated aluminum roofing is supported by 2-inch thick fiberboard roof decking (fig. 14) applied to trusses 4'-0" o.c. The fiberboard decking serves as insulation, with its underside exposed as ceiling, except in bath, hall, and utility room where perforated aluminum is used. Its strength was sufficient to support workmen when the aluminum roofing was installed.

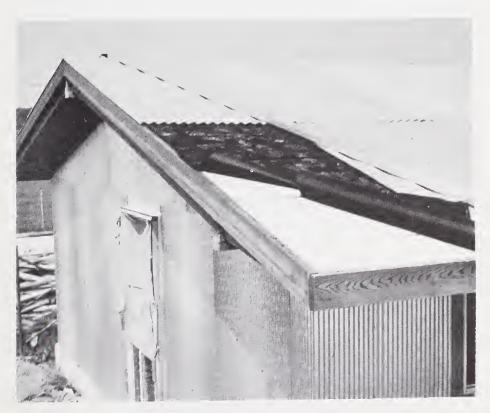
FIGURE 14.--Fiberboard roof decking, House E.

The fiberboard roof decking serves efficiently as insulation and shows no signs of sagging or other deterioration. Interior walls have retained their semisatin finish, the resilient tile floor is giving good service, and the heating unit which replaced the heat pump provides uniform trouble-free heating.
